On the Thermophysical Performance Optimization of Italian Schools of the 60s: A Case Study in Ostia (RM)

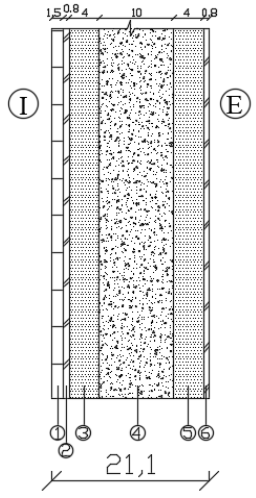
The stratigraphy was established starting from information provided by the technical staff of the school and in-situ surveys. The stratigraphy and the theoretical transmittance value are reported in Table 1. The total thickness of the external walls is about 21 cm (Fig. 3).

Fig. 3 – Stratigraphy of the wall

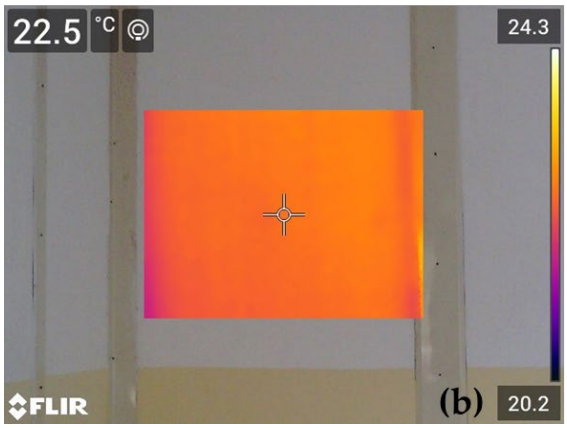
Fig. 4 – External (a) and internal (b) infrared thermography survey

The measurement campaign was conducted in April 2019 by means of a heat-flow meter through which heat fluxes, and indoor and outdoor temperatures were acquired. In addition, a thermographic survey was conducted in order to identify both thermal bridges in the structure and for the proper installation of the heat-flux sensor (see Fig. 4).
